**Visual Simulation 1:
Western Corridor from Upper
Thumb Picnic Area at Peña
Blanca Lake Recreation Area.**

**Visual Simulation 2:
Western Corridor from Ruby
Road west of the Calabasas
Group Area.**

**Visual Simulation 3:
Western Corridor along Ruby
Road north of Pajarita
Wilderness.**

**Visual Simulation 4:
Western Corridor and Castle
Rock from Ruby Road.**

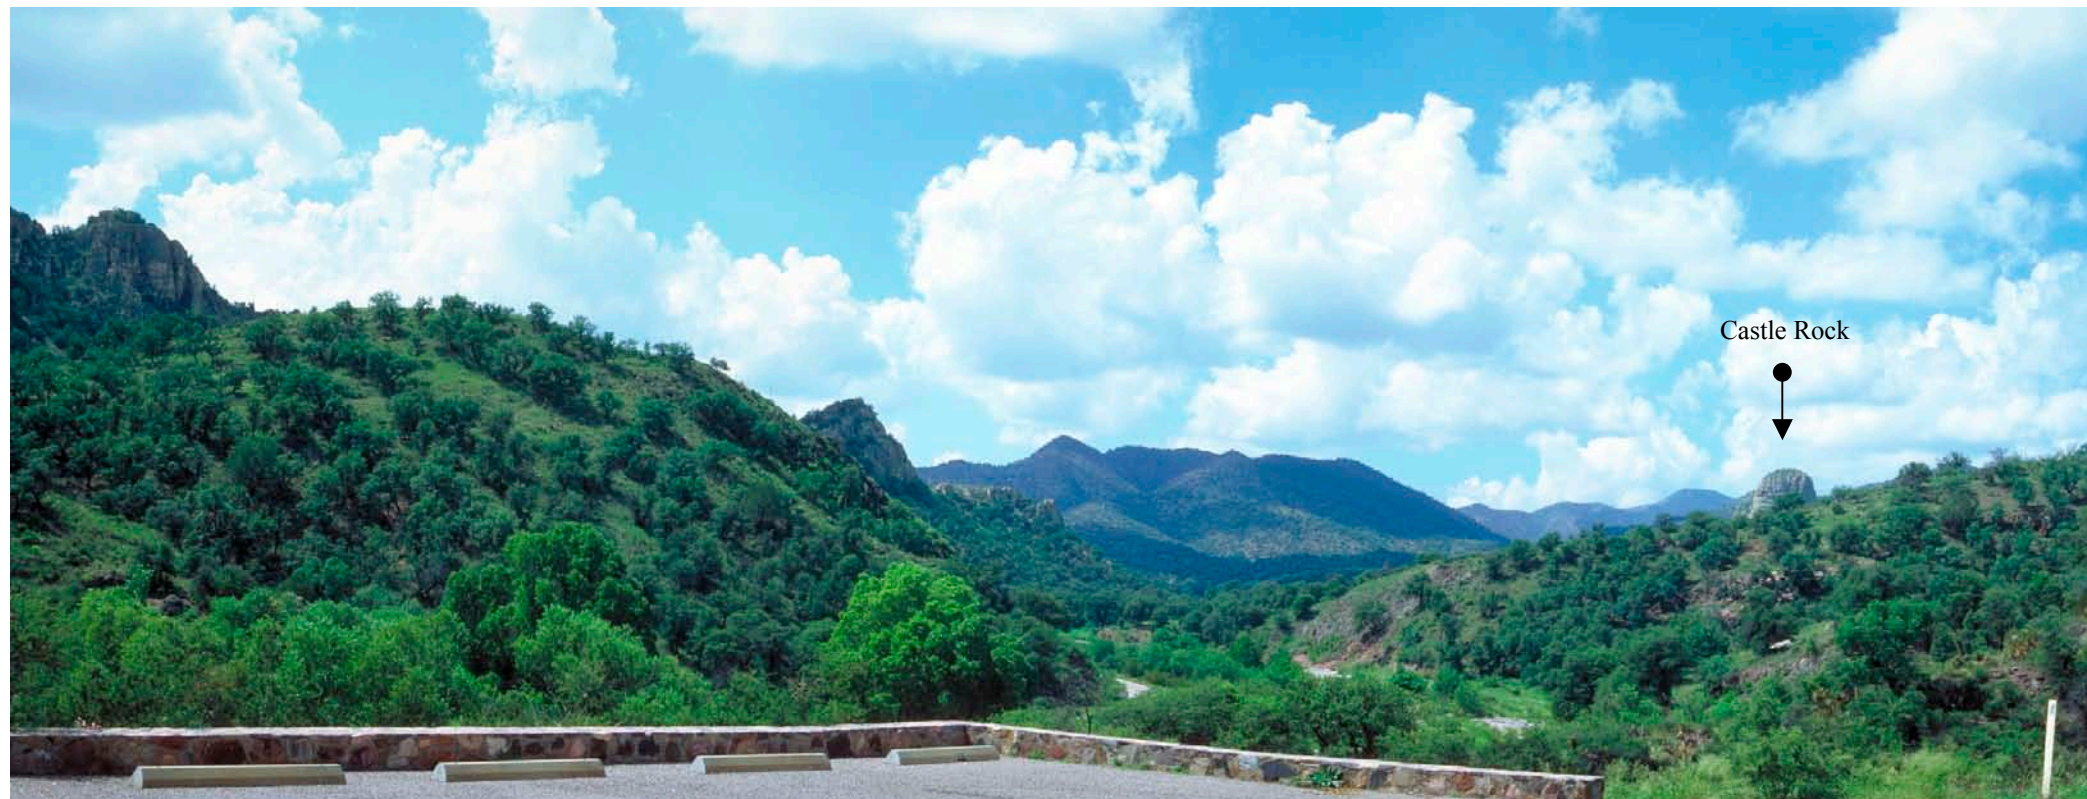
Existing Conditions: View from Upper Thumb Picnic Area looking down Peña Blanca Canyon towards Castle Rock.

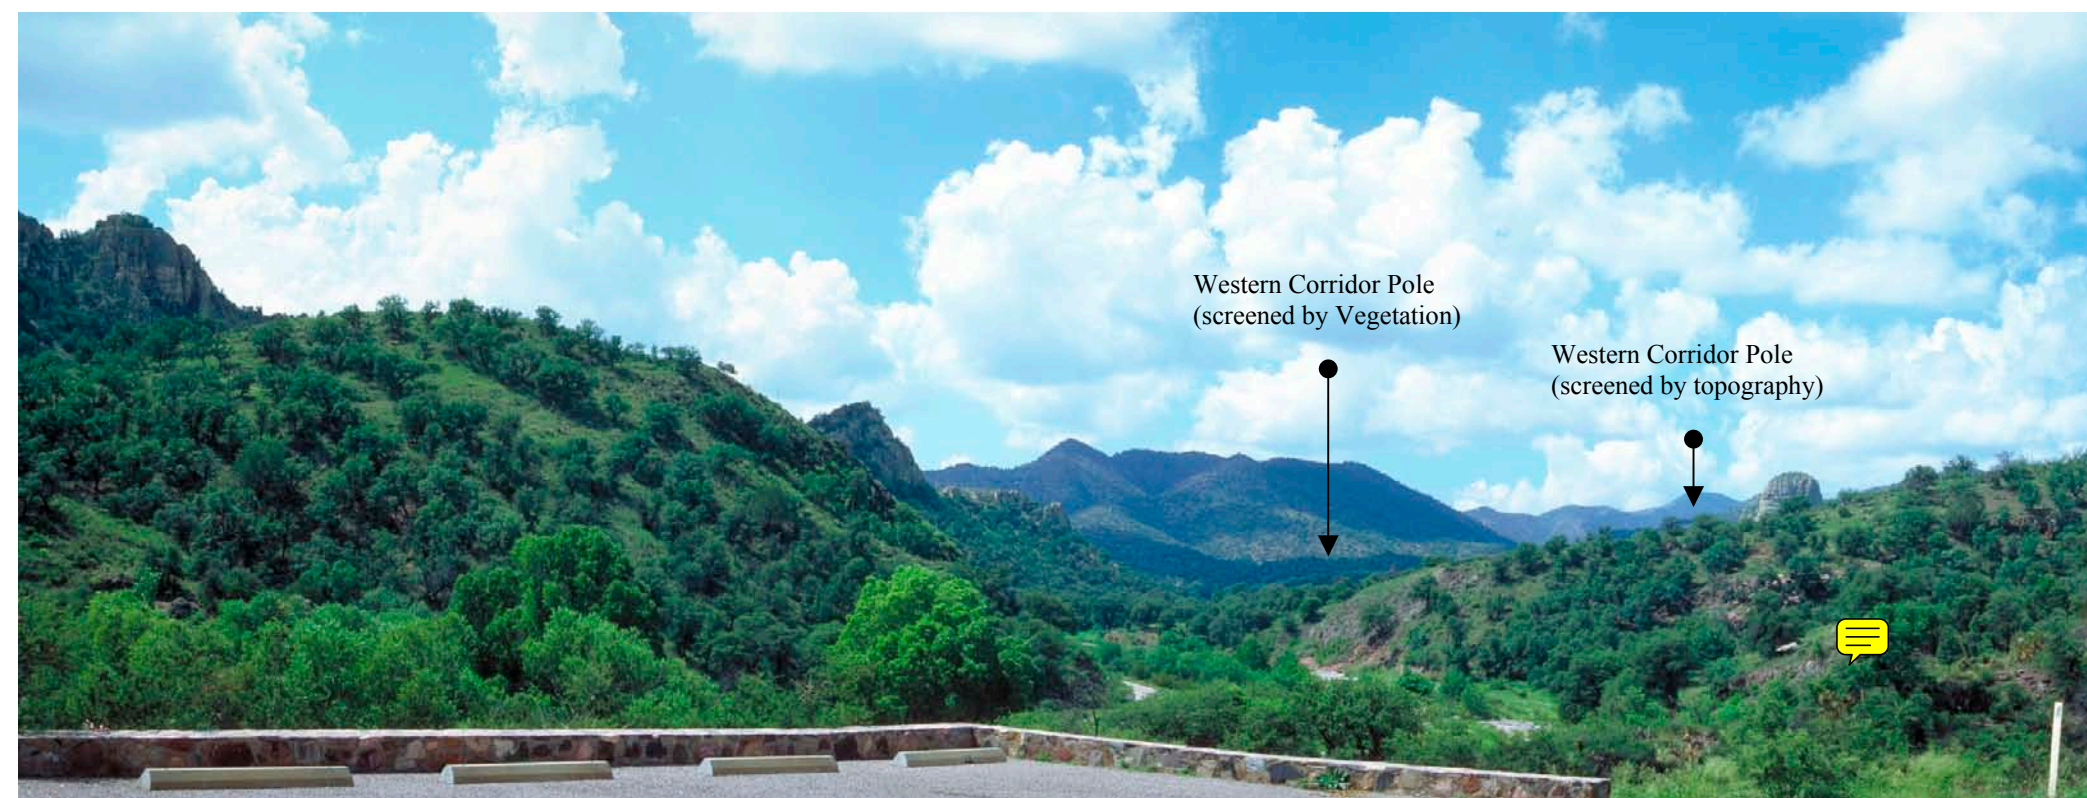
An example, partially-blocked view
of the Western Corridor from a
Concern Level 1 travelway.

Direction: Southwest

Distance to Nearest Pole: 1.2 mi

Visual Simulation: Depicting self-weathering monopoles.

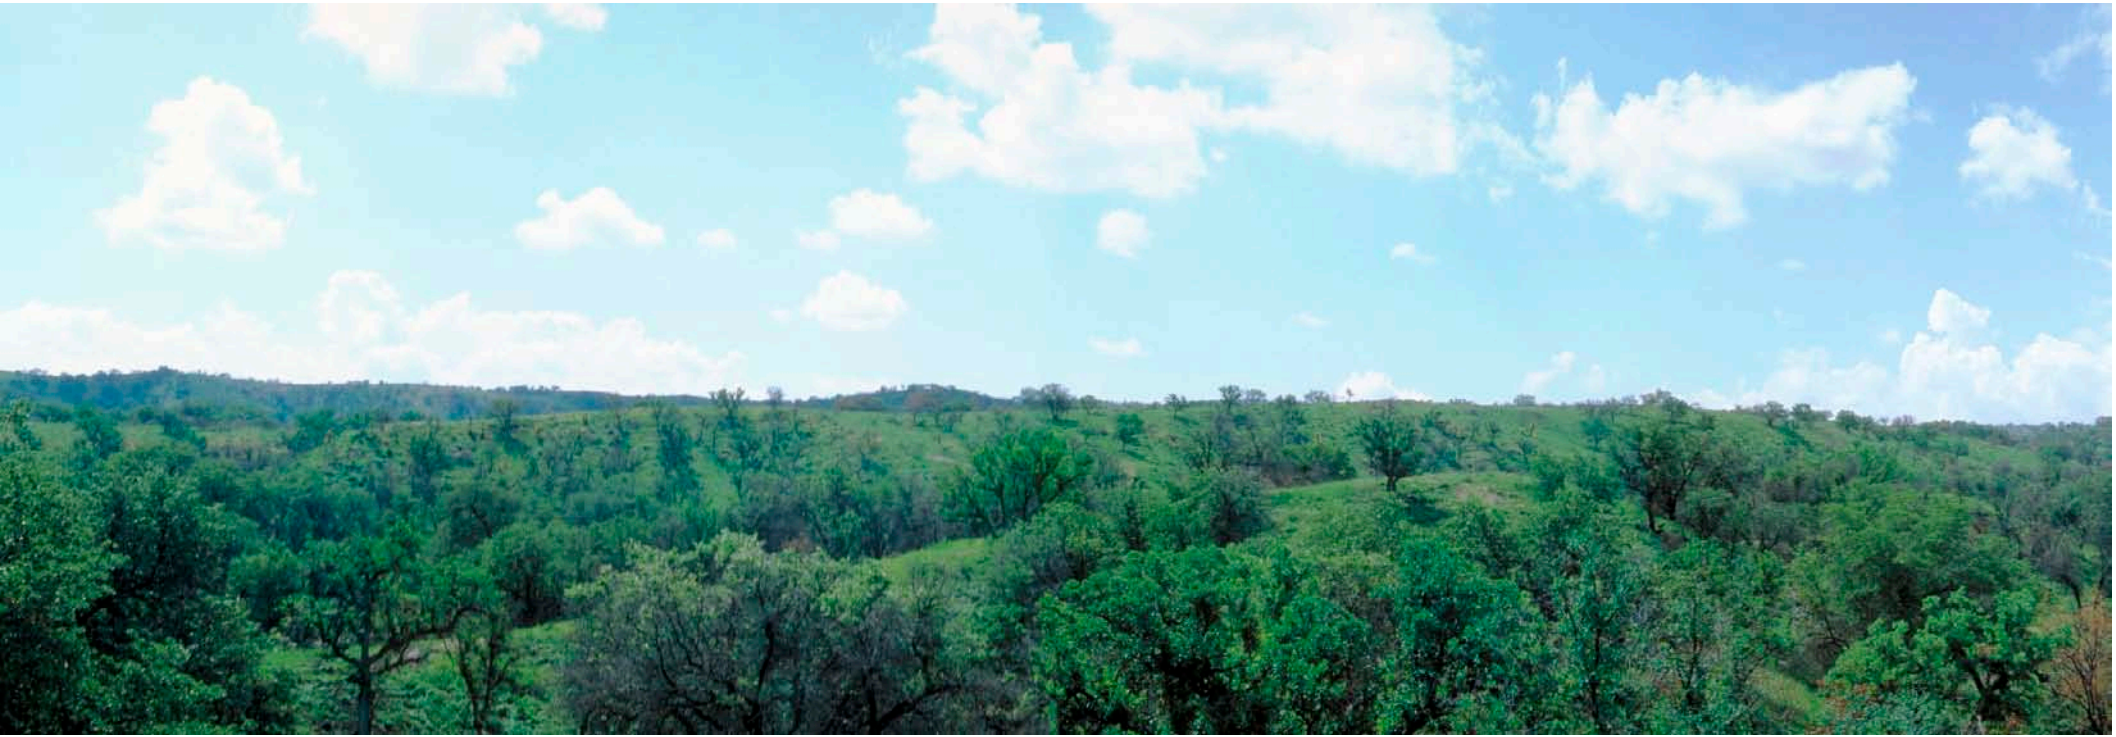
Existing Conditions: View from Ruby Road west of the Calabasas Group Area.

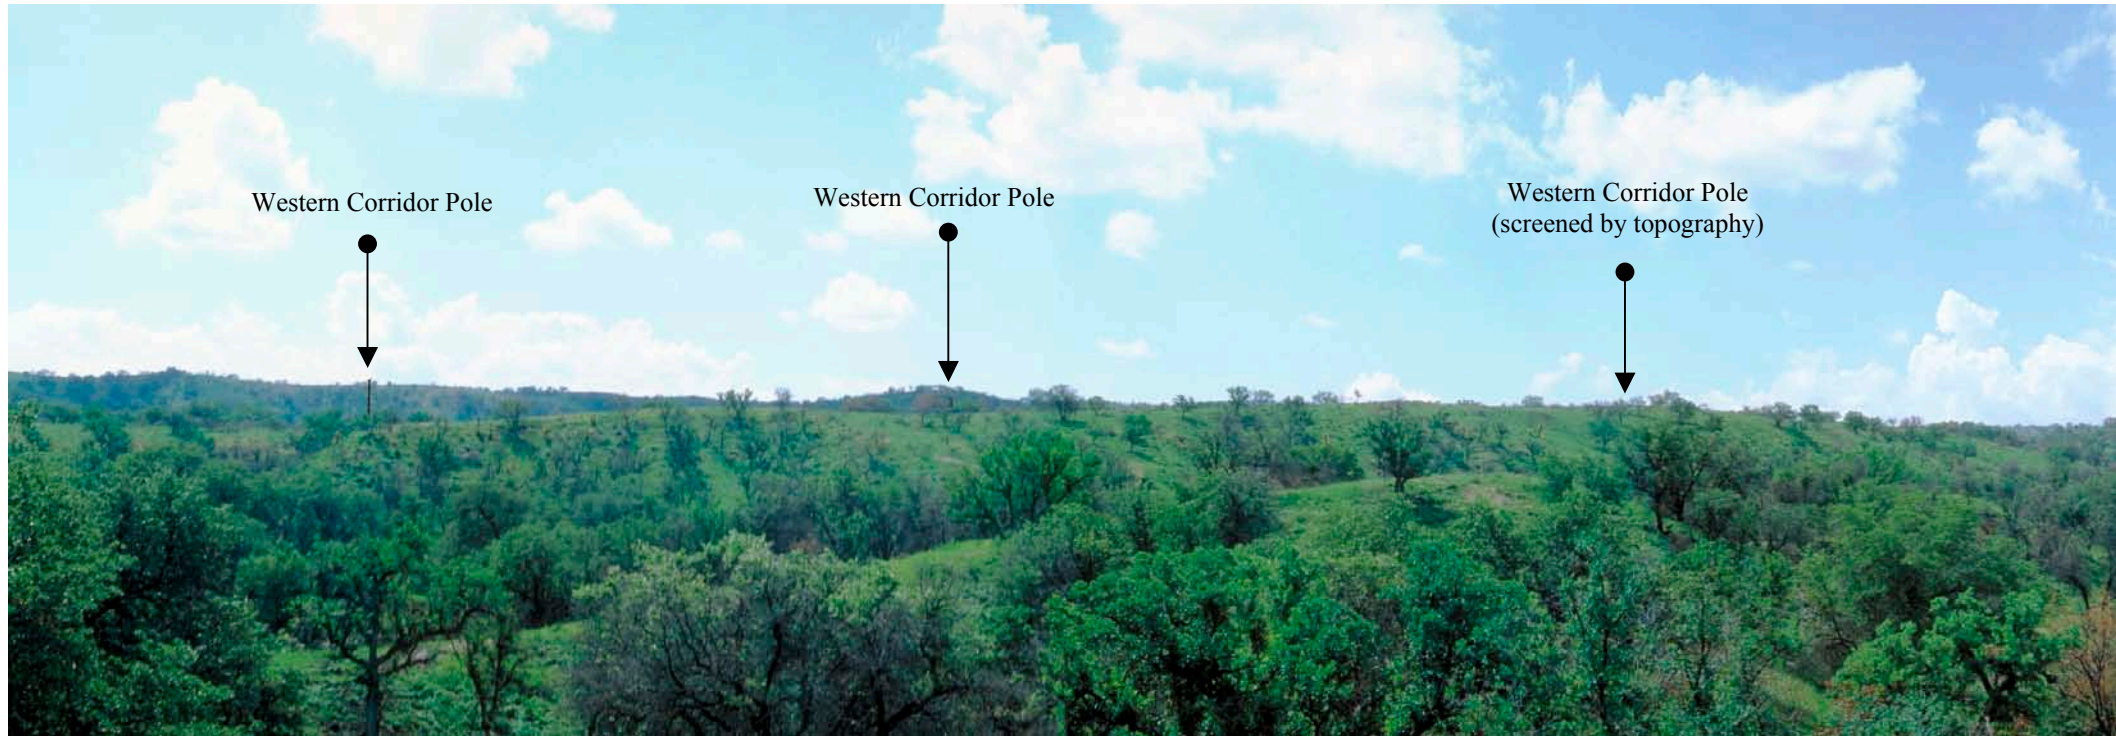
An example, partially-blocked view
of the Western Corridor from a
Concern Level 1 travelway.

Direction: South
Distance to Nearest Pole: 0.4 mi

Visual Simulation: Depicting self-weathering monopoles.

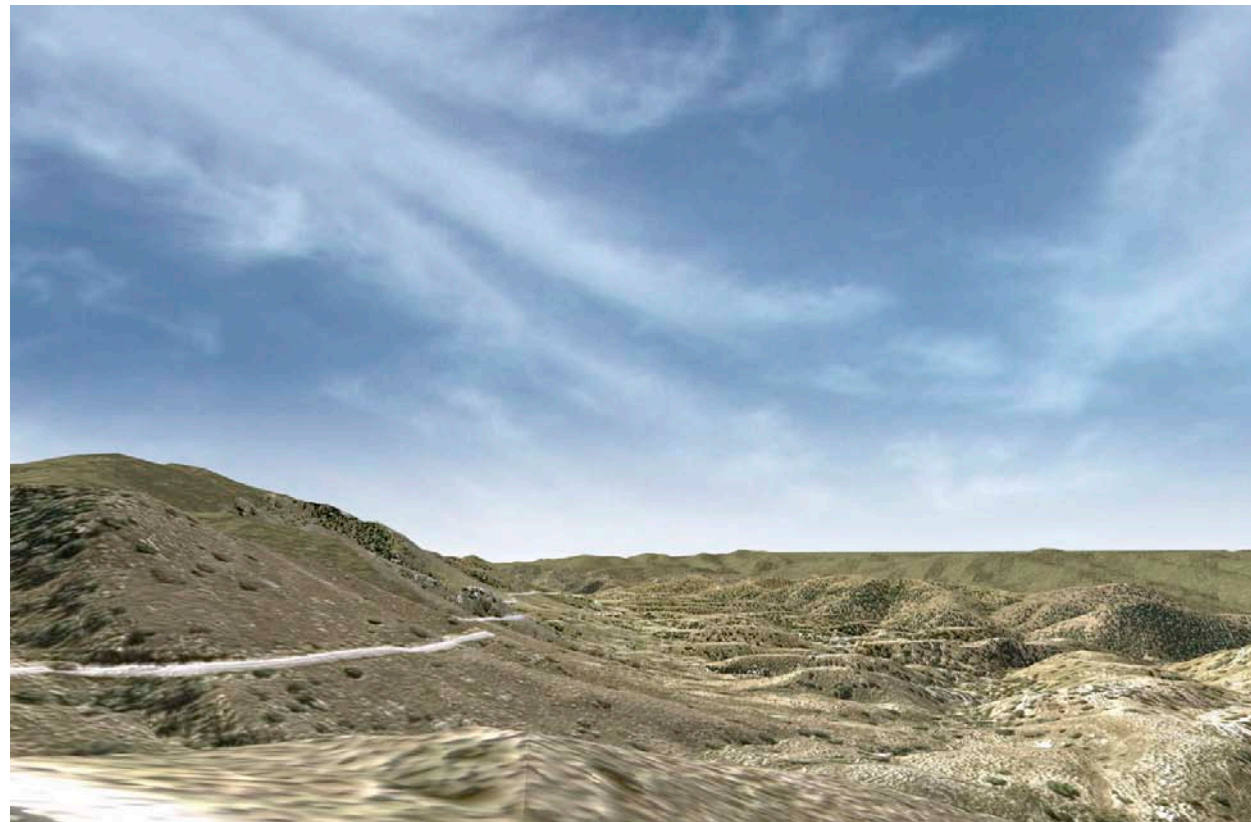
Existing Conditions: View looking southwest along Ruby Road, north of the Pajarita Wilderness.

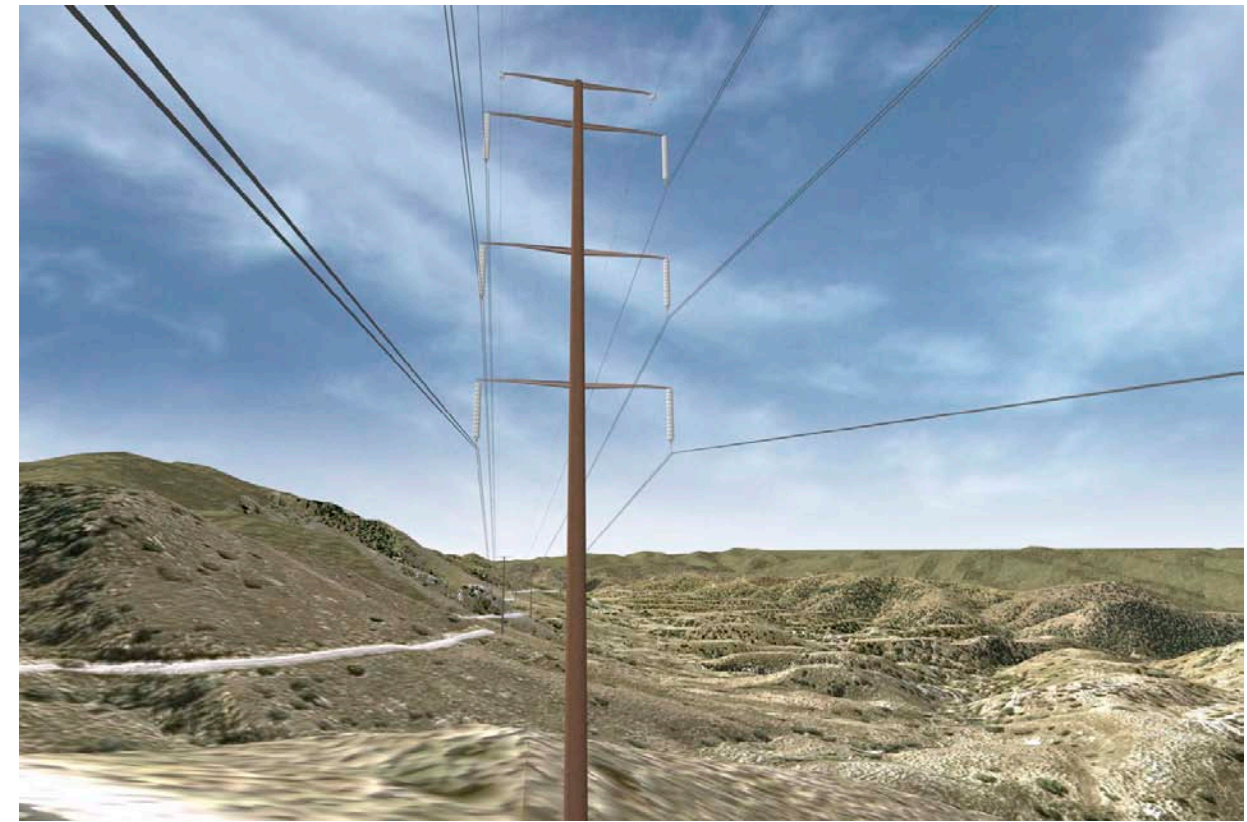
Visual Simulation: Depicting self-weathering monopoles.

An example, wide-open view of the
Western Corridor from a Concern
Level 1 travelway.

Direction: Southeast

Distance to Nearest Pole: .01 mi

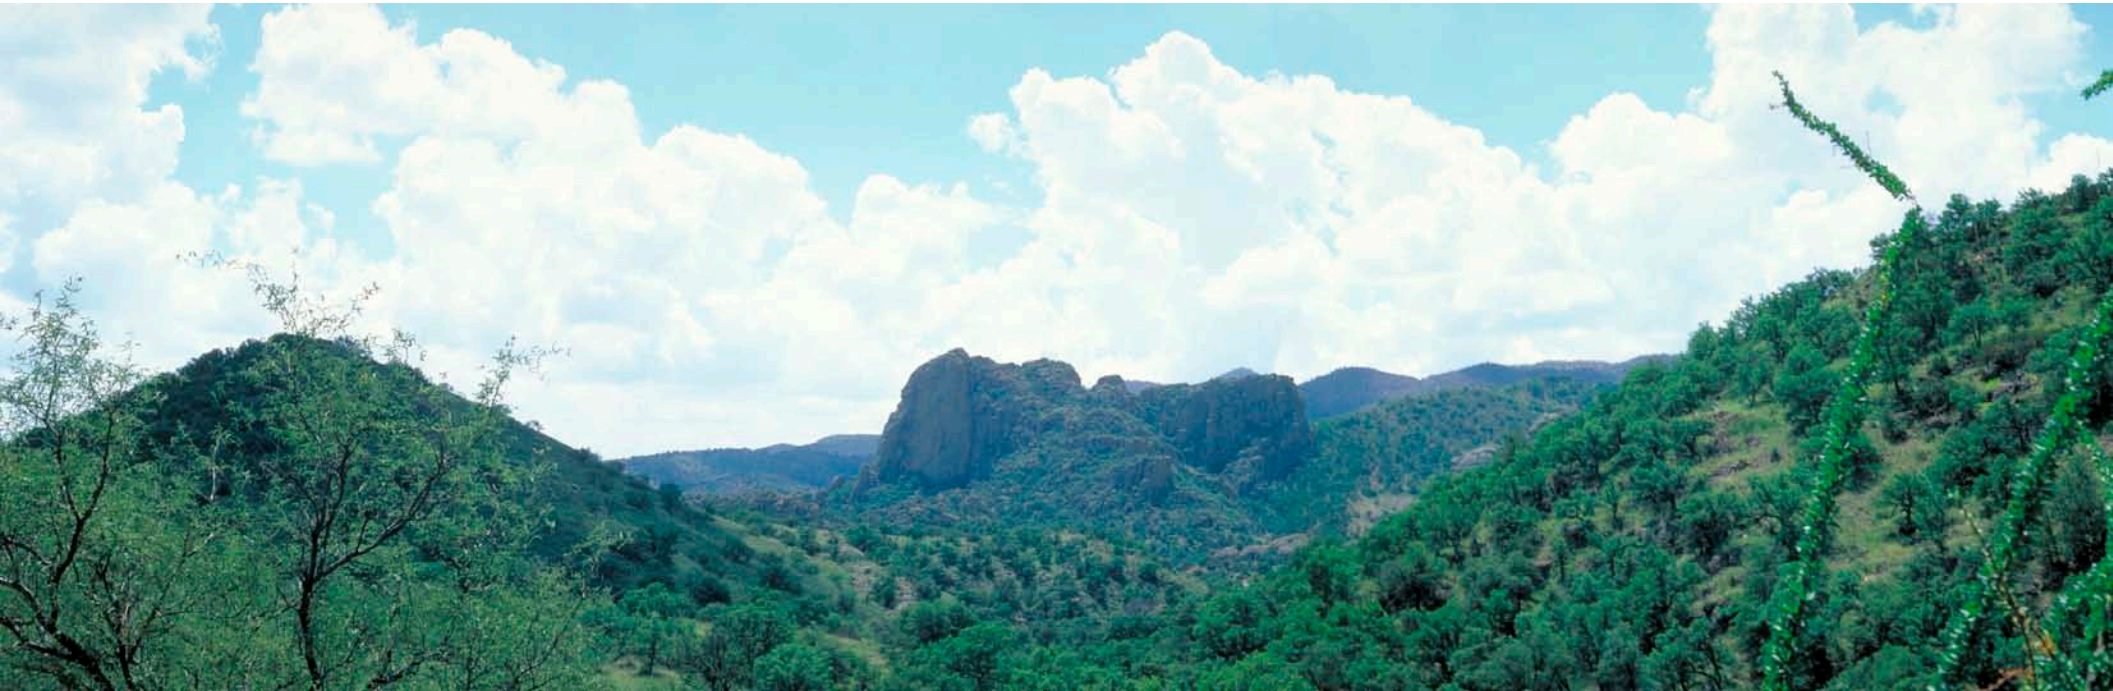
Existing Conditions: View from Ruby Road toward Castle Rock.

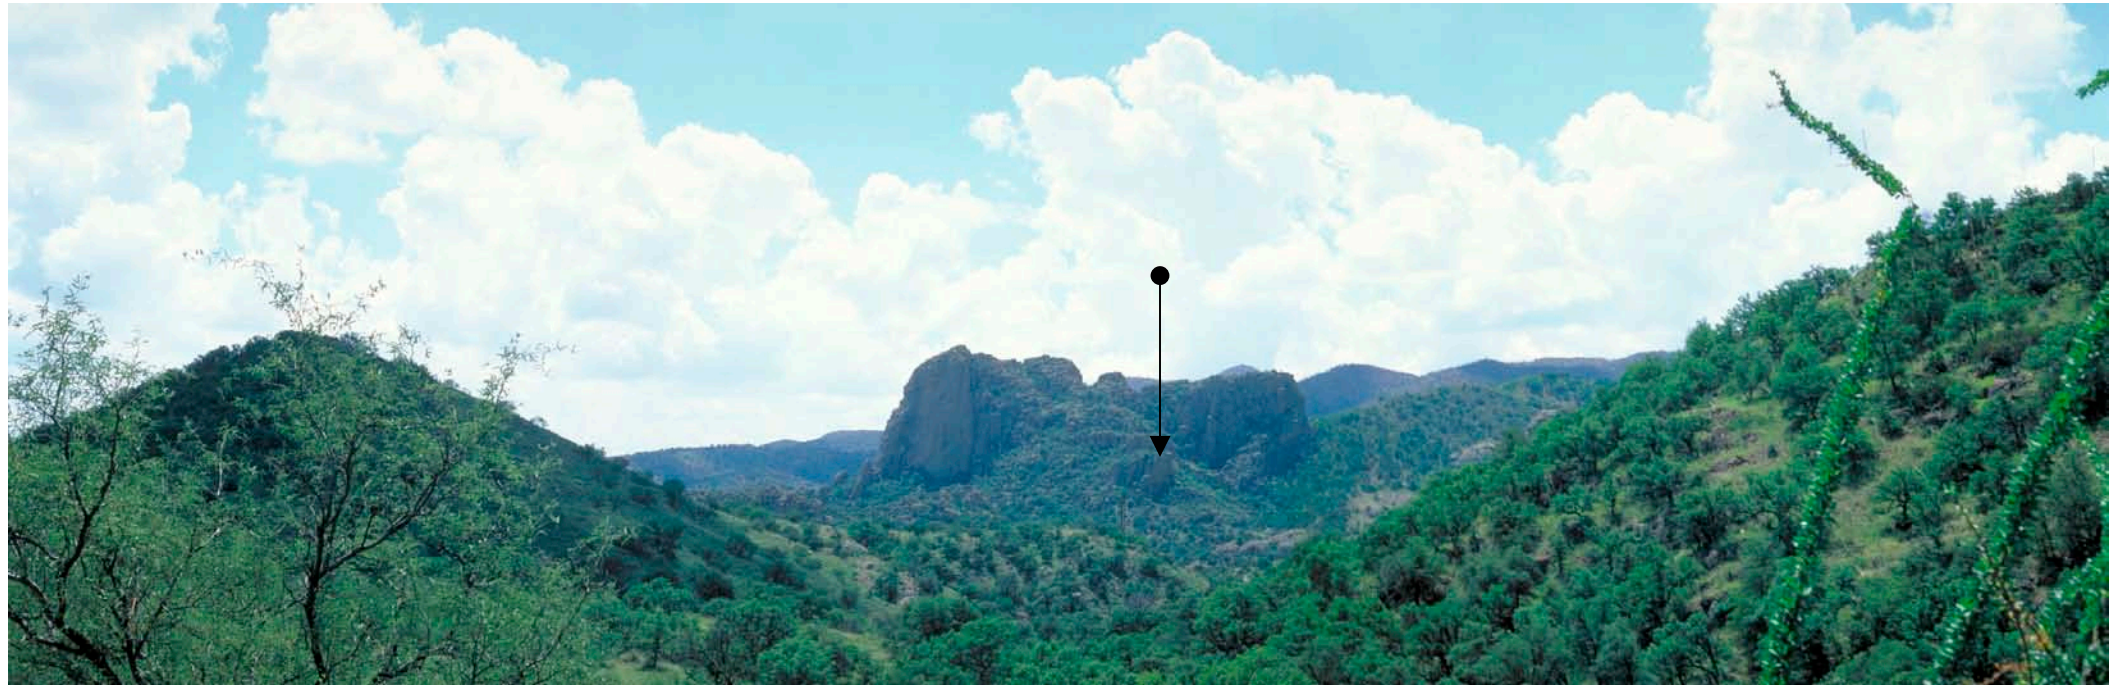
Visual Simulation: Depicting self-weathering monopoles.

An example, partially-blocked view
of the Western Corridor from a
Concern Level 1 travelway.

Direction: Southeast
Distance to Nearest Pole: 0.4 mi

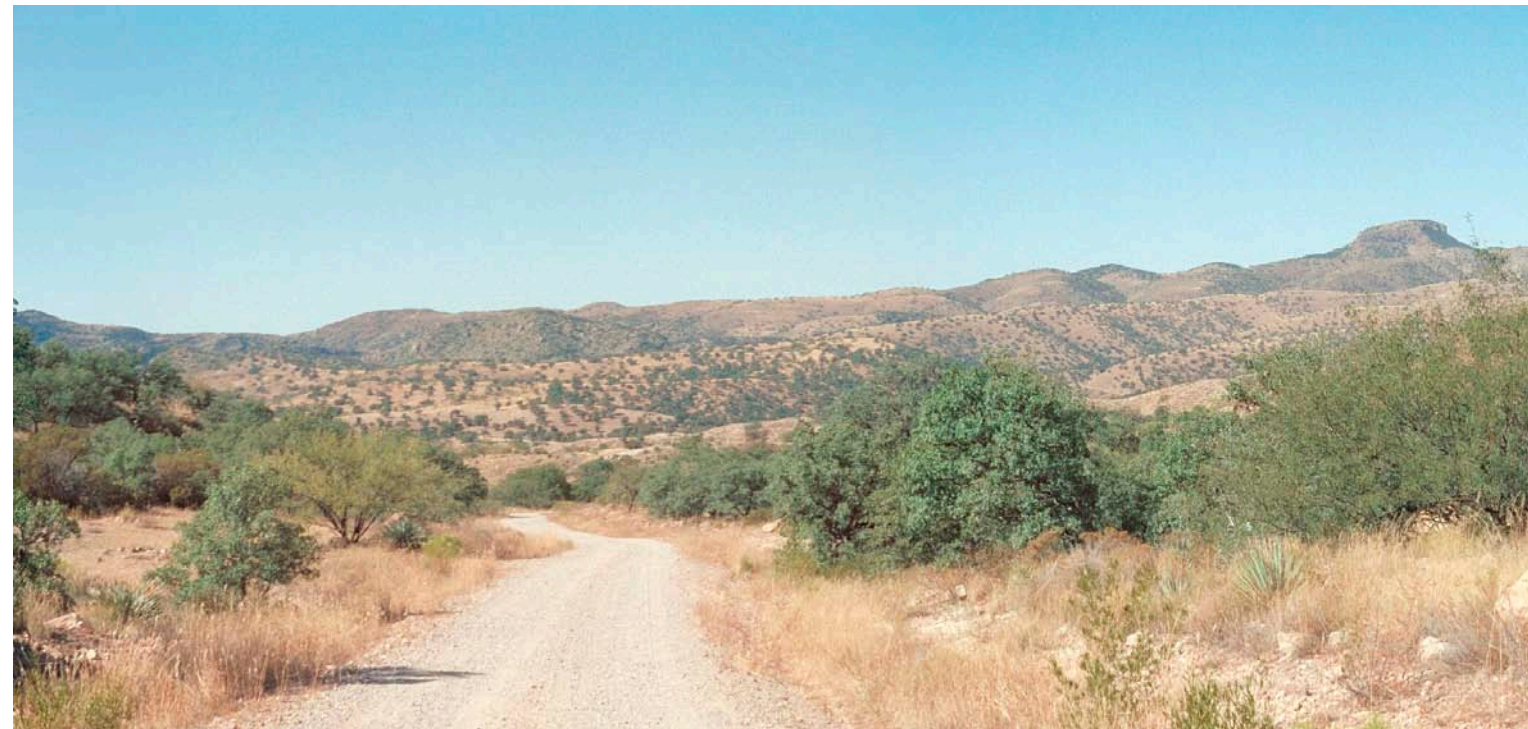
Existing Conditions: Western Corridor crossing Site of Ruby Road looking Westbound.

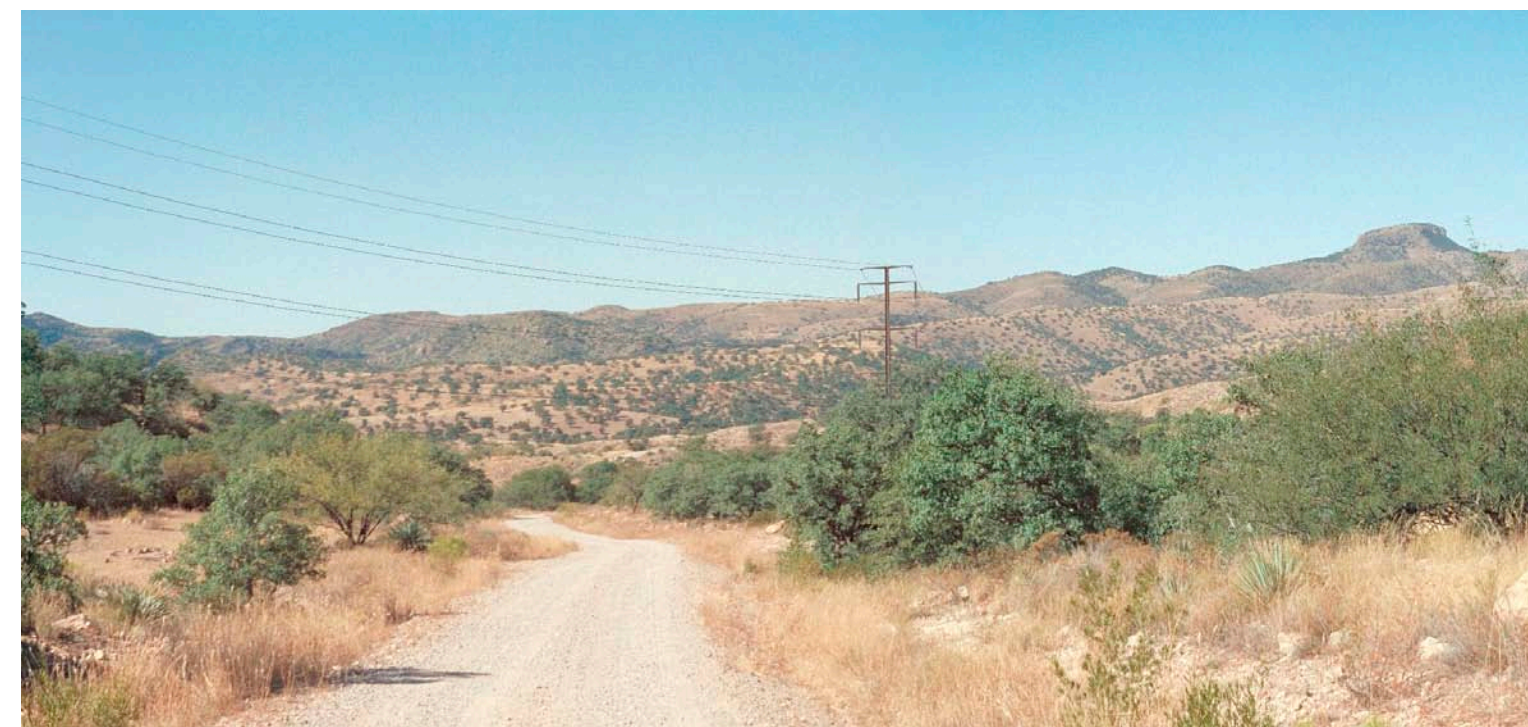
**Visual Simulation 5:
Western Corridor Crossing Ruby
Road.**

An example, wide-open view of the Western Corridor from a Concern Level 1 travelway.

Direction: West

Distance to Nearest Pole: 0.06 mi

Visual Simulation: Depicting Self-weathering Monopoles.
